Case Study:

# Elim Church, Jamaica Street, Bristol.

*An unusual scenario for fire protection, but a fine demonstration of the versatility of cast epoxy intumescent—and the benefits of installing Interactive Columns.*

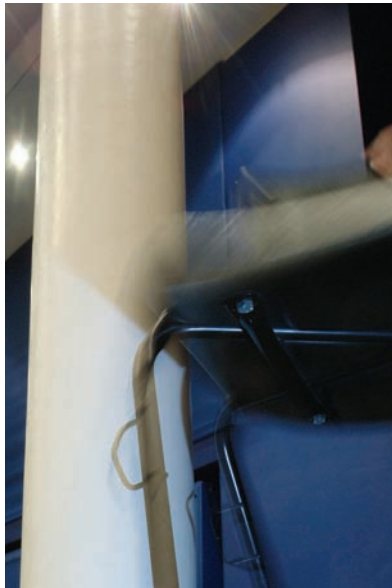
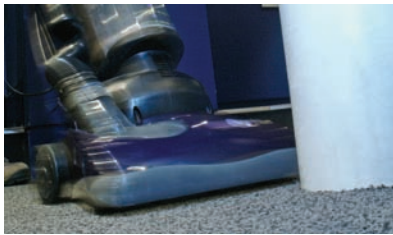
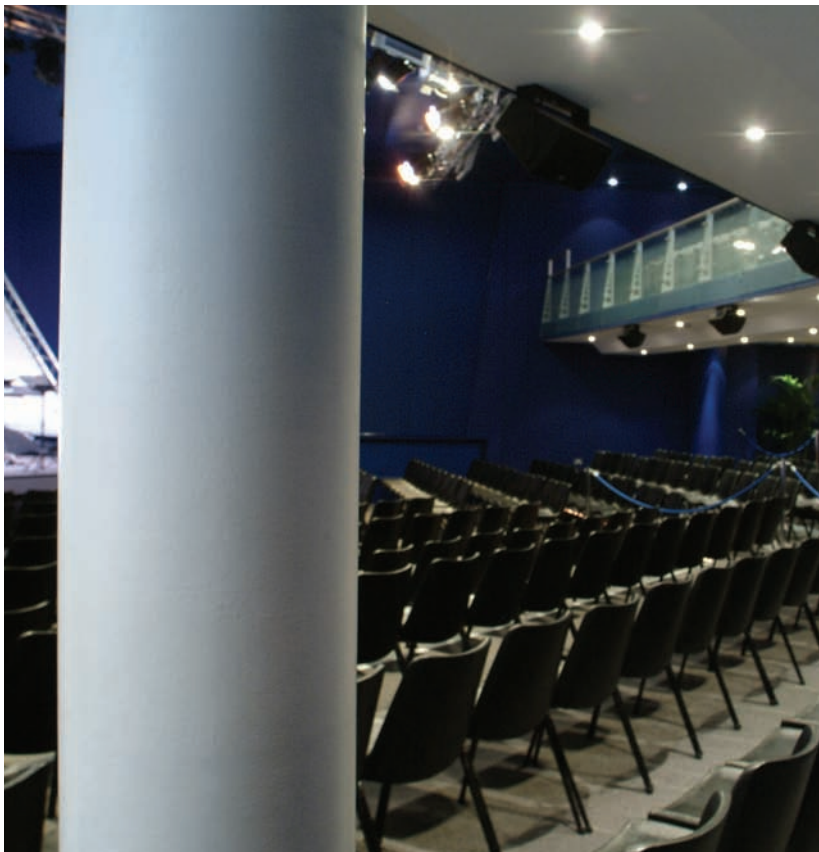
Firstly, the church needed a flexible seating arrangement to cater for the different kinds of service and function running through a normal week. Stackable, metal-supported plastic chairs are used and these come into very close proximity to the two feature columns. Daily moving of the chairs results in the columns taking many knocks and scrapes.

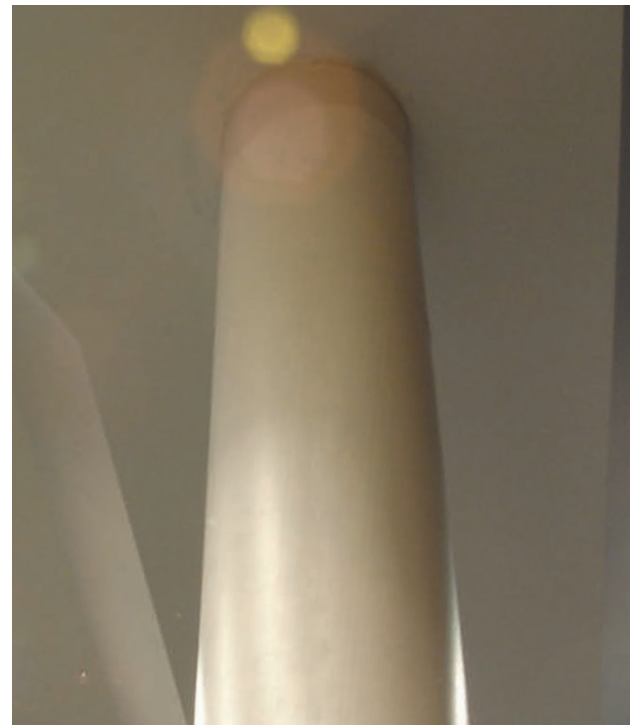
The combination of fire protection, usage and aesthetics led the architect to consider *Interactive Columns*—and soon realise only this product could meet all his requirements. While *Interactive Columns* would offer up to two hours fire protection, it was the robustness of the cast epoxy intumescent they are formed from—and the ease with which the surface could be repaired without trace—that was the main attraction.

The superior, slim and stylish appearance of the columns was a welcome bonus.

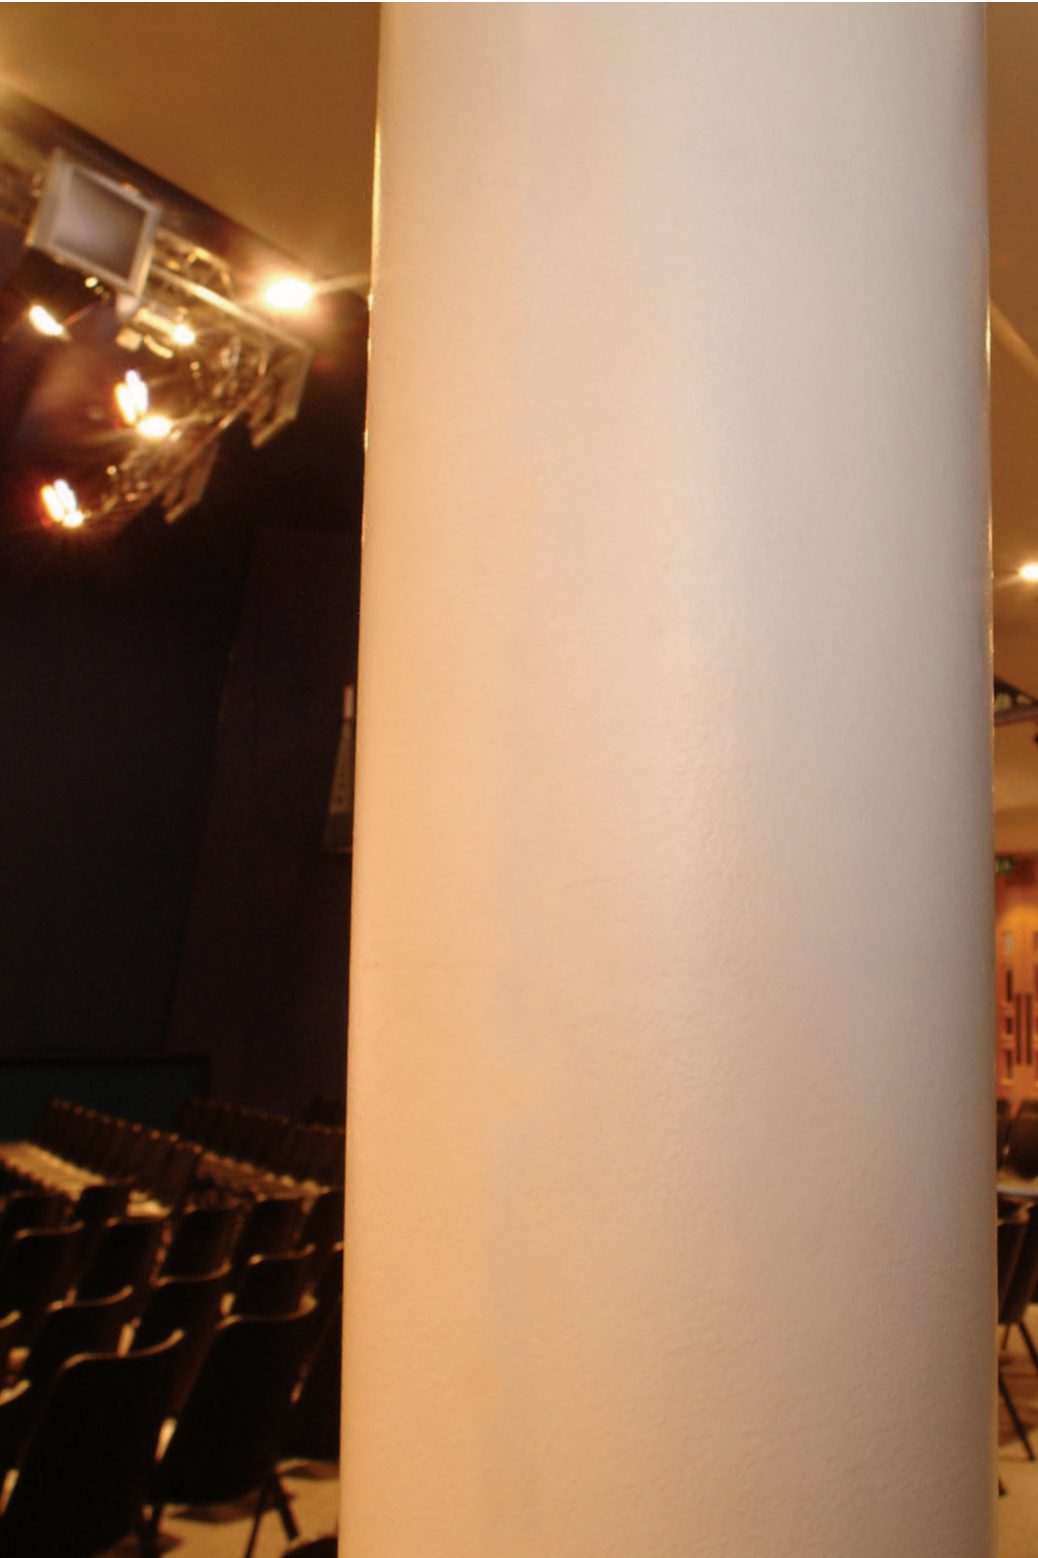
# An attractive solution with the advantage of durability and low cost maintenance

As the basic requirement was for only 30 minutes fire protection, there would never be a need to re-instate the system. A simple, easily sourced, two-pack filler could be used to fill any chips (followed by a roller-applied application of the decorative top seal). This is a job any good decorator, or maintenance person, could accomplish in an hour.
